# Il Ciclo di Vita dei Materiali Compositi

## Certificazione e Controlli non Distruttivi

Magnaghi is **Bombardier Aerospace TIER1 Supplier** for CSERIES program (CS100 and CS300) providing the following fully qualified CFRP primary structure components:

- LH/RH Inboard Flaps
- LH/RH Outboard Flaps
- LH/RH Ground Spoilers
- LH/RH Multifunctional spoilers 8-off (4 off LH – 4 off RH)
- MLG Upper-Middle-Lower Doors

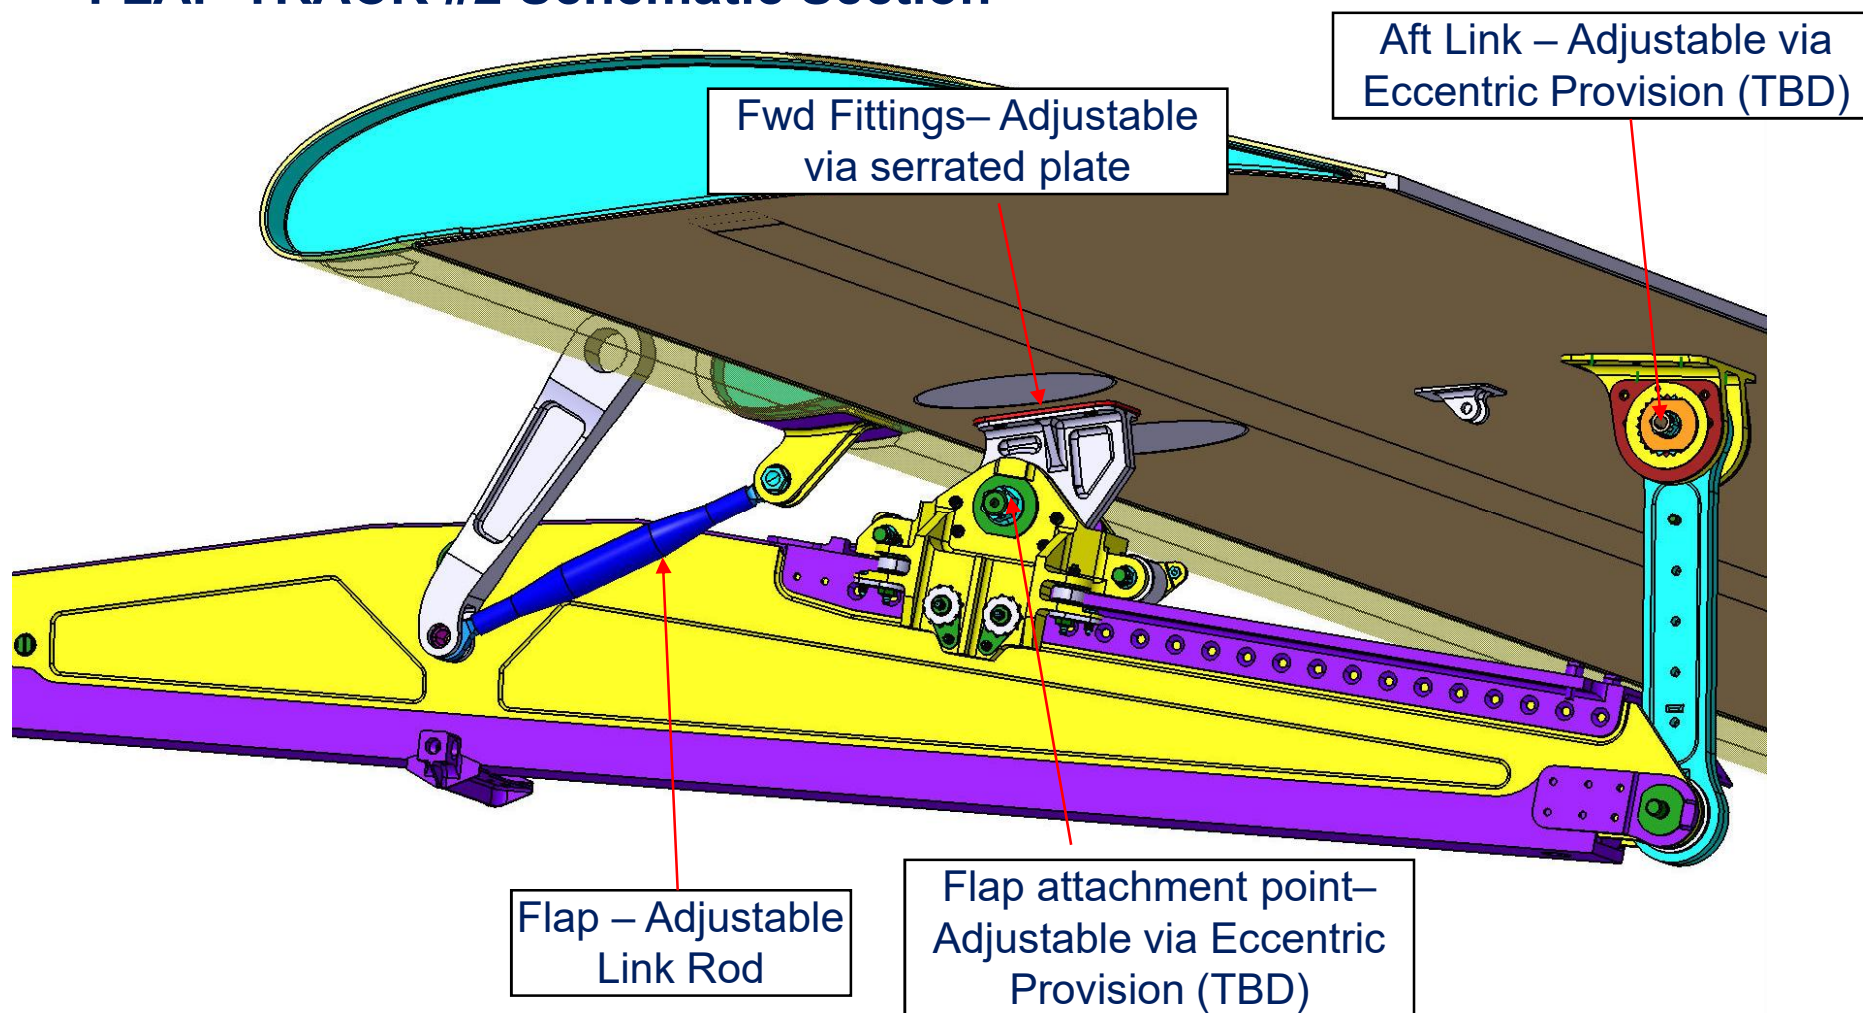
### Inboard Flap Overview – Rigging

\* Rigging Required to Achieve Aero smoothness Criteria

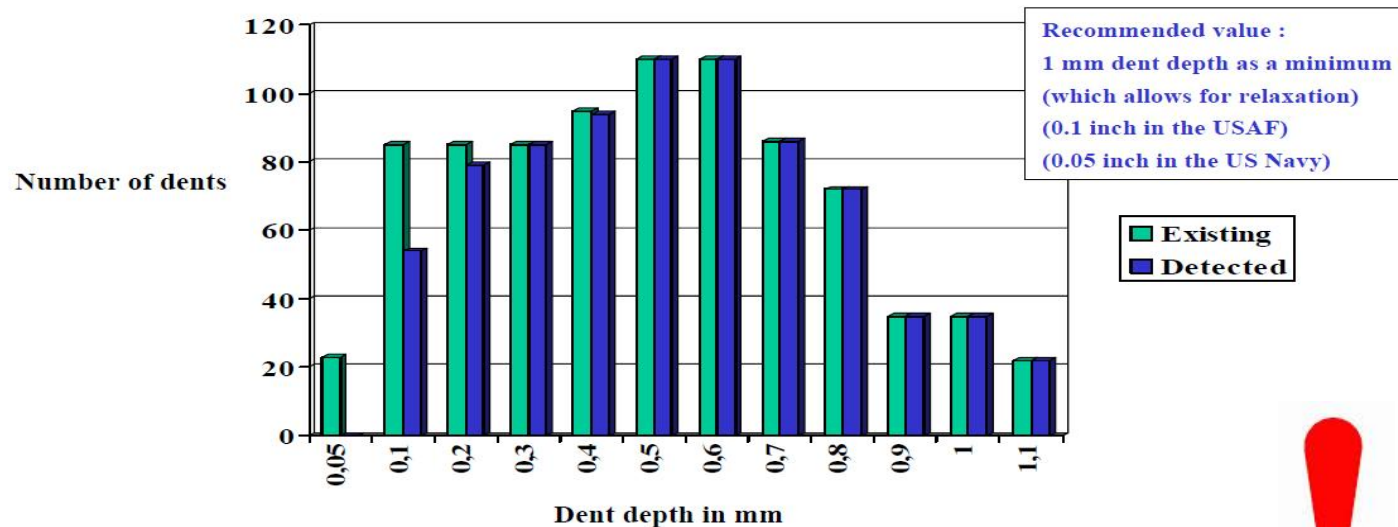
#### Defining detectability threshold

Results of an investigation carried out at EADS - Louis Bleriot research centre

-the maximum size that a normal inspector may overlook?

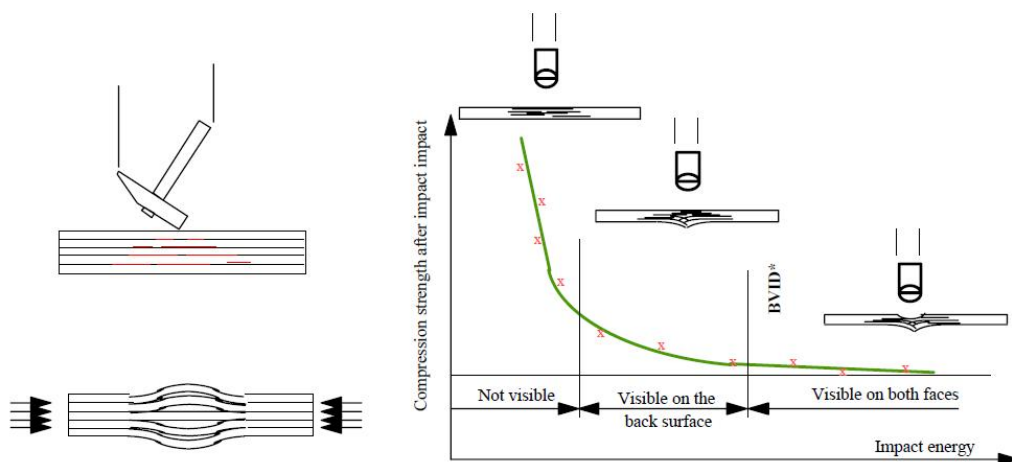
**LARGE STATIC STRENGTH REDUCTIONS MAY OCCUR BEFORE DAMAGE BECOMES DETECTABLE**

\* BVID = Barely Visible Impact Damage

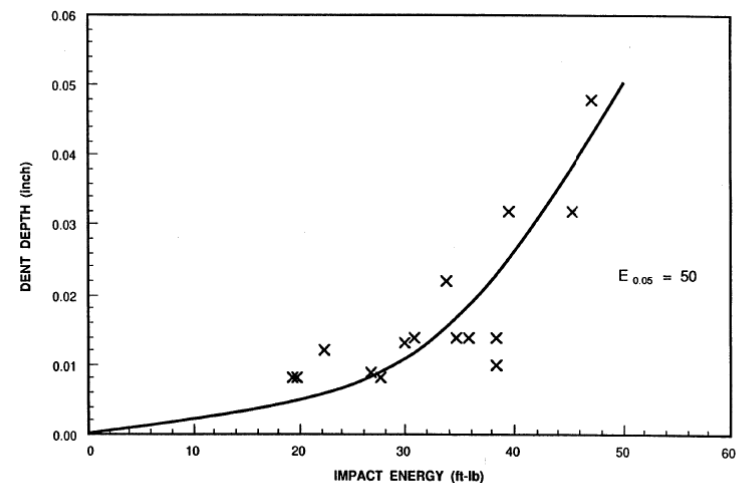
Figure 11. Relationship Between Dent Depth and Impact Energy for  $0.20 \leq t \leq 0.25$  inch.

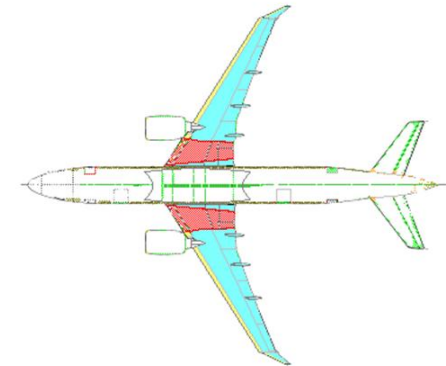
The dent depth thresholds of detectability for BVID are:

- 1mm applied under Detailed Visual Inspection (DVI)
- 2.5mm General Visual Inspection (GVI)

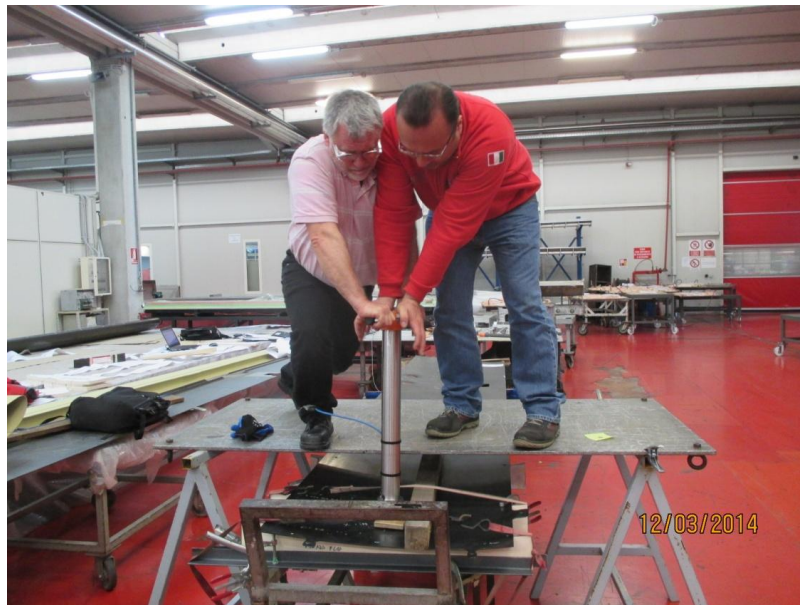
Gun Impactor

- Two Impactors have been used
  - Manual gun impactor, capable to apply impact energies up to 110 J
  - Tower impactor, capable to apply impacts energies up to 290 J

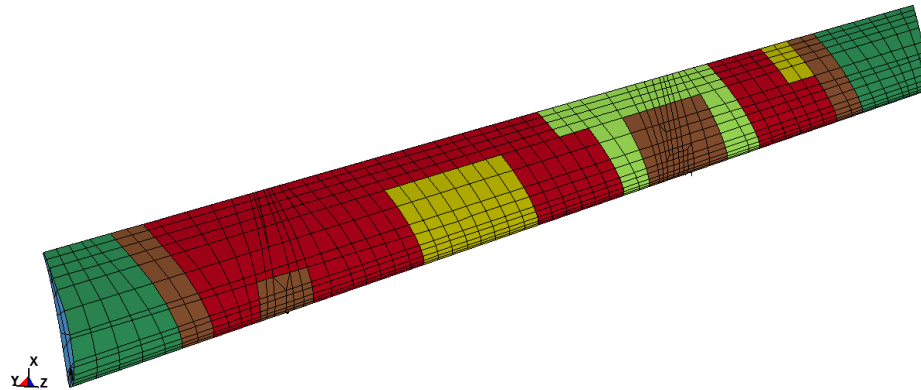
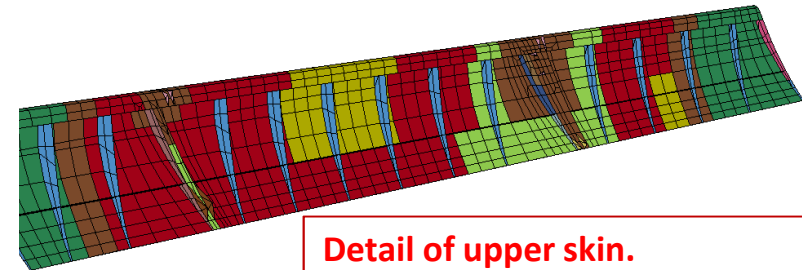
### Coarse to fine mesh

Detail of upper skin.  
Typical element size is: 4 to 5" inches

Upper skin including ribs, stringer and co-cured spars are modelled as “coarse” mesh.

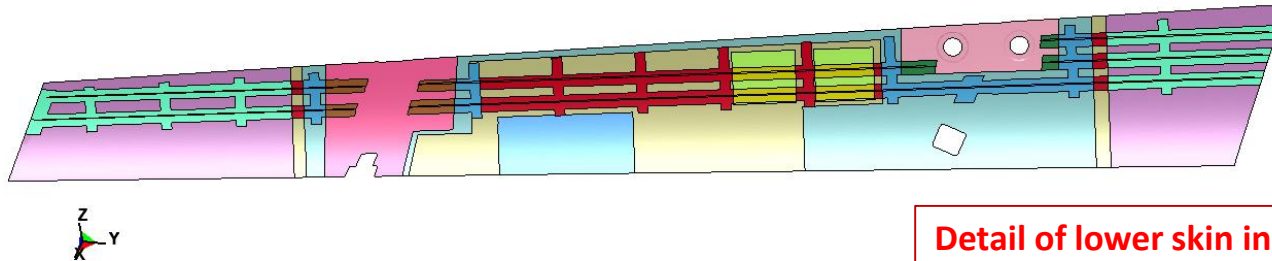
Detail of lower skin inspection holes  
Typical element size is 0.2 inches

Lower skin subject to impact event are meshed as “fine” and includes stringer web, inspection holes and stringer runout

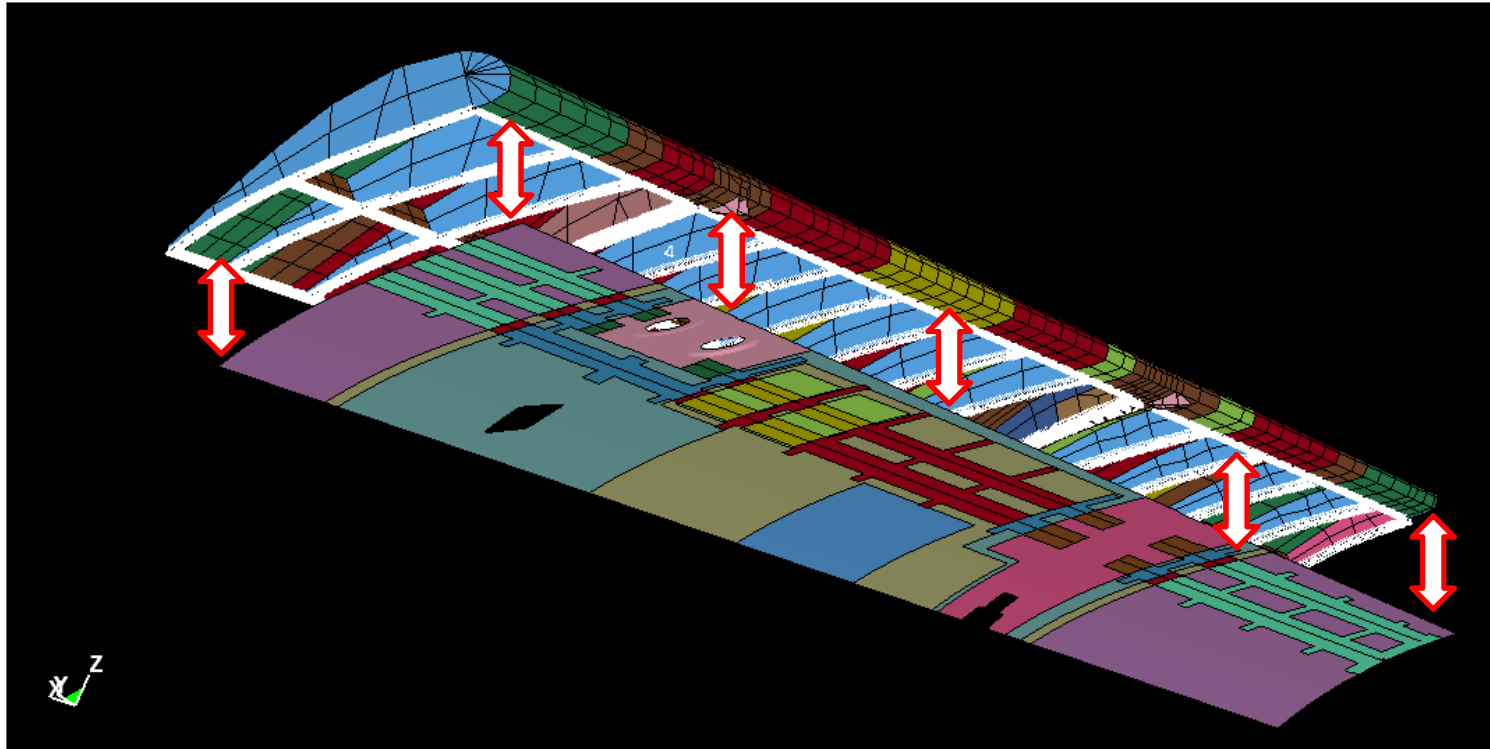
### Coarse to fine mesh

TIED SHELL EDGE TO SURFACE OFF-SET contact formulation is used to allow shear load transmission between lower skin, ribs, and spar feet.

This approach allows to increase the level accuracy where a detailed investigation is required.

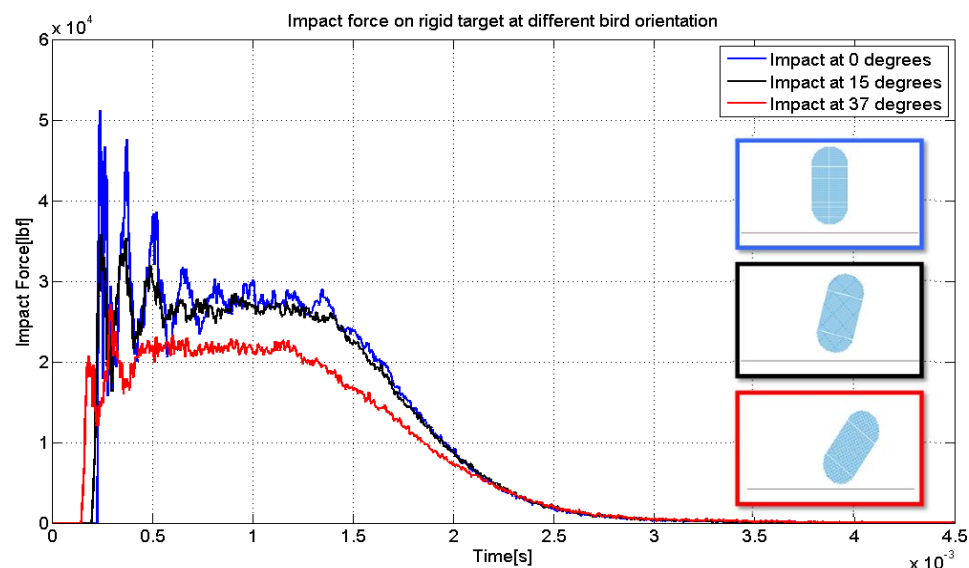
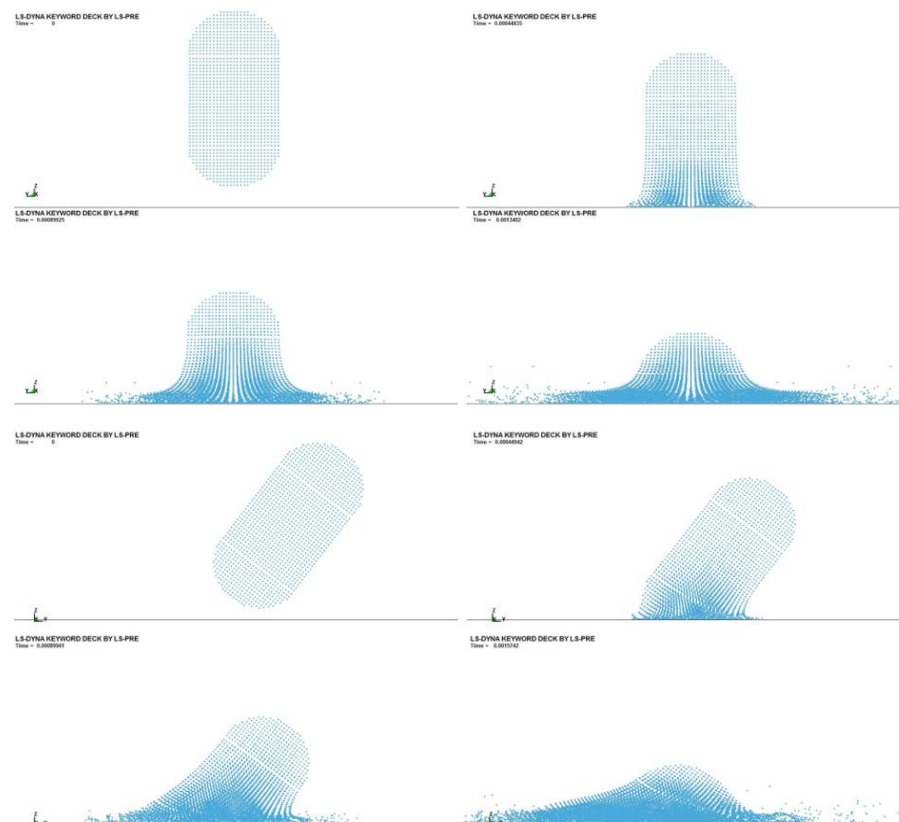
### IMPACT @ 219 Kts (113 M/s)

## Calibration of bird impact model

Velocity=219 Knot, Bird Mass=4 lb	Momentum Transfer [lb·s]	Empirical Formula [lb·s]	LS-DYNA MAT_RIGID [lb·s]	LS-DYNA MAT_ELASTIC [lb·s]
0°	48596	37790	51228	60199
15°	46940	36502	35776	54807

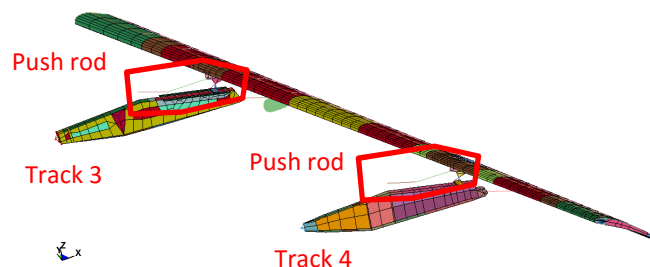
## Bird Impact analysis. Result

Flap	Impact ID	Max Bird Impact Force	FWD push rod track #3		
			Minimum Peak from Bird Strike Analysis	Maximum Peak from Bird Strike Analysis	(Max DesignLoad-Max Bird Impact Force)/Max DesignLoad
37 deg	18	13292	-5889	5097	74%
37 deg	6	13986	-14320	1203	36%
37 deg	7	13140	-14430	313	36%
37 deg	8	13694	-10520	5775	53%
37 deg	9	13237	-5235	2108	77%
37 deg	10	13503	-5041	2533	77%
37 deg	11	13585	-2766	2281	88%
37 deg	12	14122	-9745	5413	56%
37 deg	13	14008	-4886	773	78%
37 deg	14	14599	-6878	400	69%
37 deg	15	13069	-2771	419	88%
37 deg	16	11835	-5382	1916	76%
37 deg	17	14963	-5325	899	76%
25 deg	18	8273	-2007	1444	91%
25 deg	7	11500	-6400	1552	71%
25 deg	19	8325	-1283	2633	94%

Flap	Impact ID	Max Bird Impact Force	FWD push rod track #4		
			Minimum Peak from Bird Strike Analysis	Maximum Peak from Bird Strike Analysis	(Max DesignLoad-Max Bird Impact Force)/Max DesignLoad
37 deg	18	13292	-7072	5324	49%
37 deg	6	13986	-6574	3242	52%
37 deg	7	13140	-5256	4859	62%
37 deg	8	13694	-4241	5302	69%
37 deg	9	13237	-9764	1708	29%
37 deg	10	13503	-9108	5702	34%
37 deg	11	13585	-8582	4240	38%
37 deg	12	14122	-4649	4612	66%
37 deg	13	14008	-9044	630	34%
37 deg	14	14599	-5463	2267	60%
37 deg	15	13069	-2478	51	82%
37 deg	16	11835	-11350	1486	17%
37 deg	17	14963	-6081	6796	56%
25 deg	18	8273	-1650	522	88%
25 deg	7	11500	-2338	1626	83%
25 deg	19	8325	-661	1493	95%

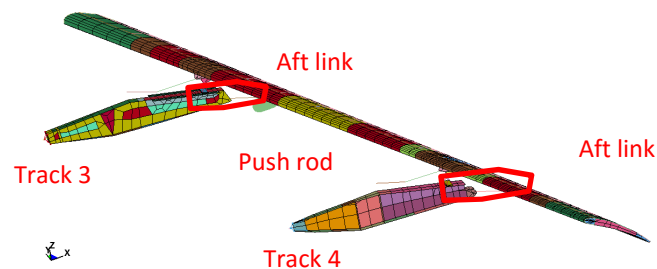
## Bird Impact analysis. Result

Flap Deployment	Impact ID	Max Bird Impact Force	AFT LINK #3		(Max DesignLoad-Max Bird Impact Force)/Max DesignLoad
			Minimum Peak from Bird Strike Analysis	Maximum Peak from Bird Strike Analysis	
37 deg	18	13292	-2079	8679	44%
37 deg	6	13986	-5301	19830	-27%
37 deg	7	13140	-942	19040	-22%
37 deg	8	13694	-1558	13960	11%
37 deg	9	13237	-1916	3858	75%
37 deg	10	13503	-1573	1614	90%
37 deg	11	13585	-1479	5277	66%
37 deg	12	14122	-4805	12210	22%
37 deg	13	14008	-2082	2723	83%
37 deg	14	14599	-5862	12350	21%
37 deg	15	13069	-185	382	98%
37 deg	16	11835	-2085	2024	87%
37 deg	17	14963	-1000	1239	92%
25 deg	18	8273	-106	6335	59%
25 deg	7	11500	-998	14850	5%
25 deg	19	8325	-1603	4104	74%

Flap Deployment	Impact ID	Max Bird Impact Force	AFT LINK #4		(Max DesignLoad-Max Bird Impact Force)/Max DesignLoad
			Minimum Peak from Bird Strike Analysis	Maximum Peak from Bird Strike Analysis	
37 deg	18	13292	-1748	8987	38%
37 deg	6	13986	-712	3394	77%
37 deg	7	13140	-2072	2338	84%
37 deg	8	13694	-1302	799	94%
37 deg	9	13237	-3169	17050	-18%
37 deg	10	13503	-3710	12250	15%
37 deg	11	13585	-1766	9229	36%
37 deg	12	14122	-1565	2561	82%
37 deg	13	14008	-2018	18210	-26%
37 deg	14	14599	-1079	11500	21%
37 deg	15	13069	-835	1859	87%
37 deg	16	11835	-381	14170	2%
37 deg	17	14963	-3653	8982	38%
25 deg	18	8273	-893	5339	63%
25 deg	7	11500	-1807	1855	87%
25 deg	19	8325	-2543	5486	62%

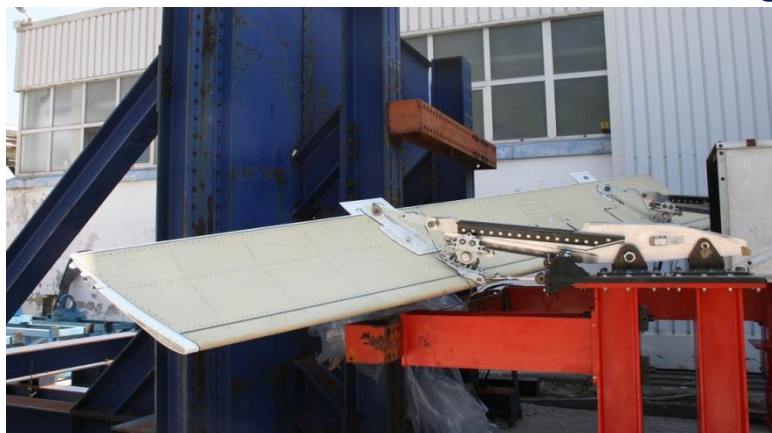
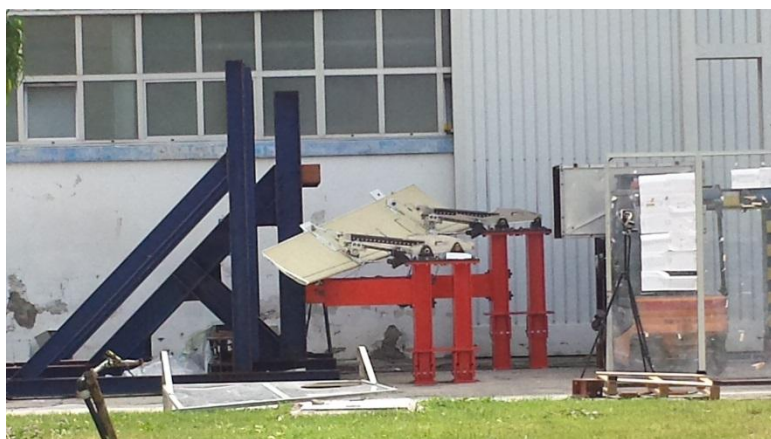
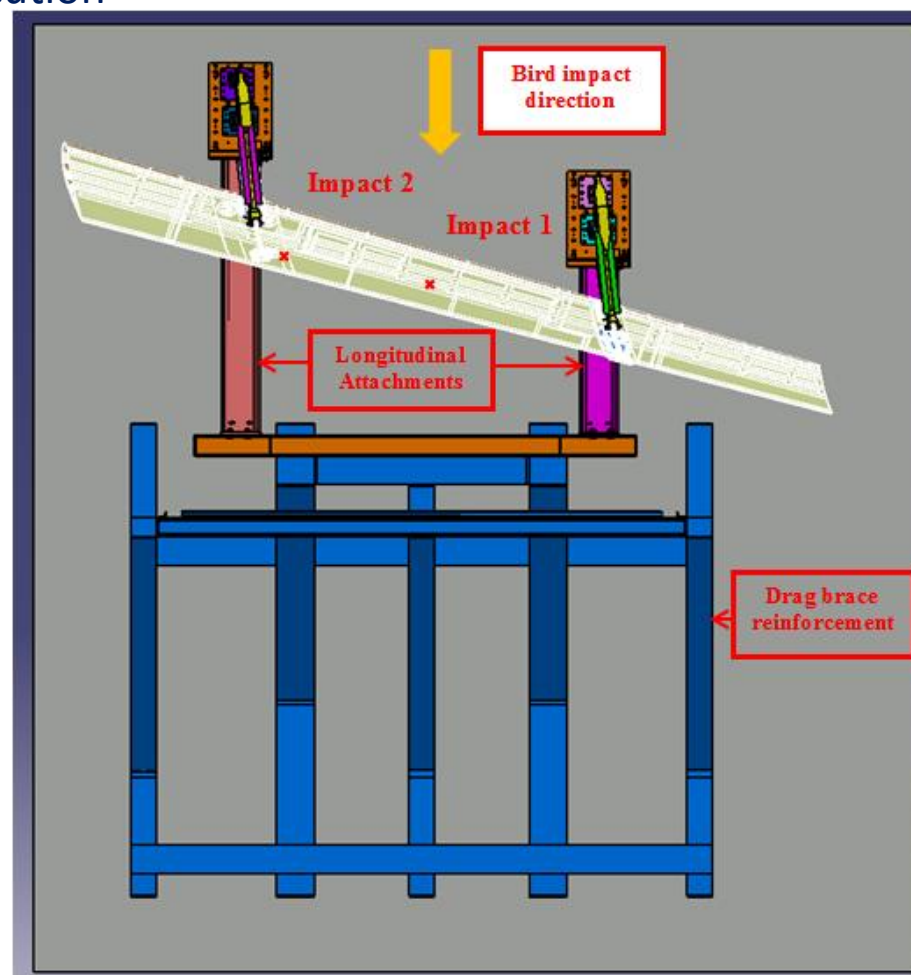
### Bird Impact Test

**AleniaAermacchi** have been selected by **Magnaghi** as LAB test supplier for bird strike test execution

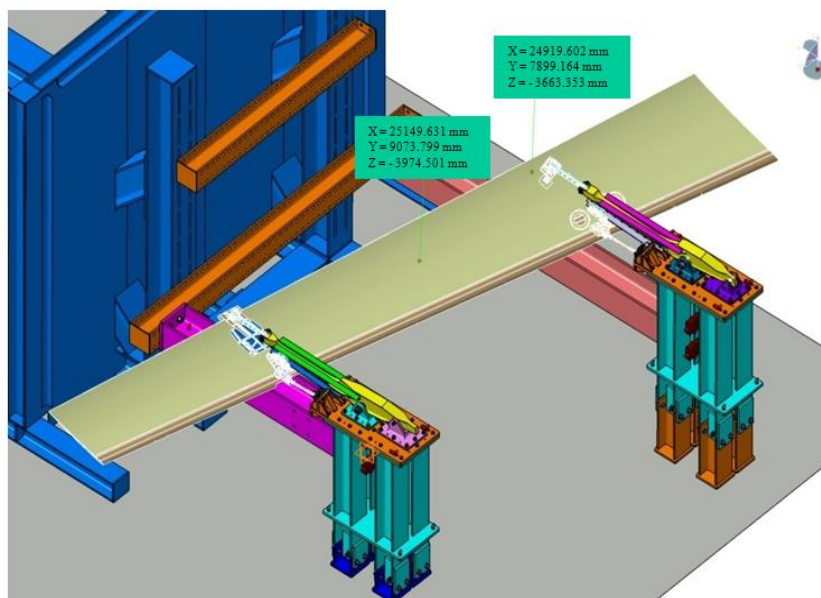
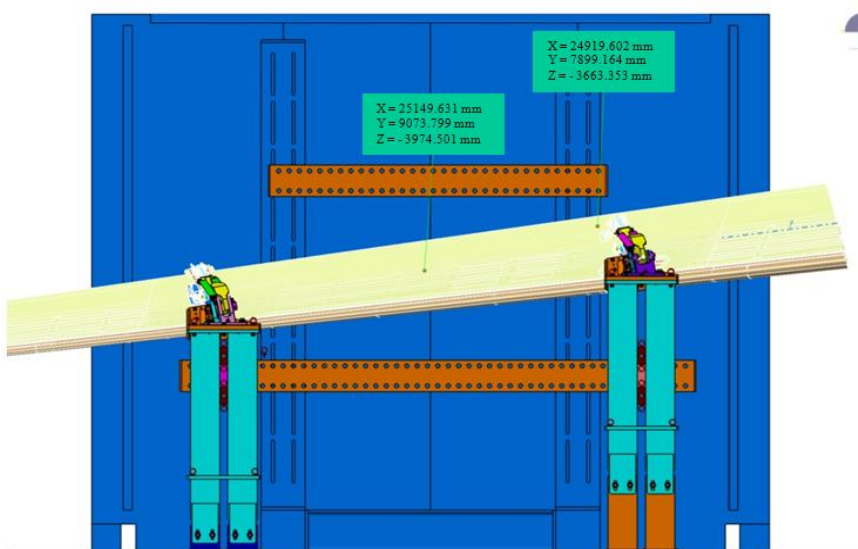
### Bird Impact Test Rig Layout

«Dummy tracks» fully reflecting actual aircraft attachment in terms of stiffness and constraints have been provided to LAB test supplier

**Bird impact test on TRACK+FLAP has been performed  
on the basis of the most critical impact point selected by analysis**

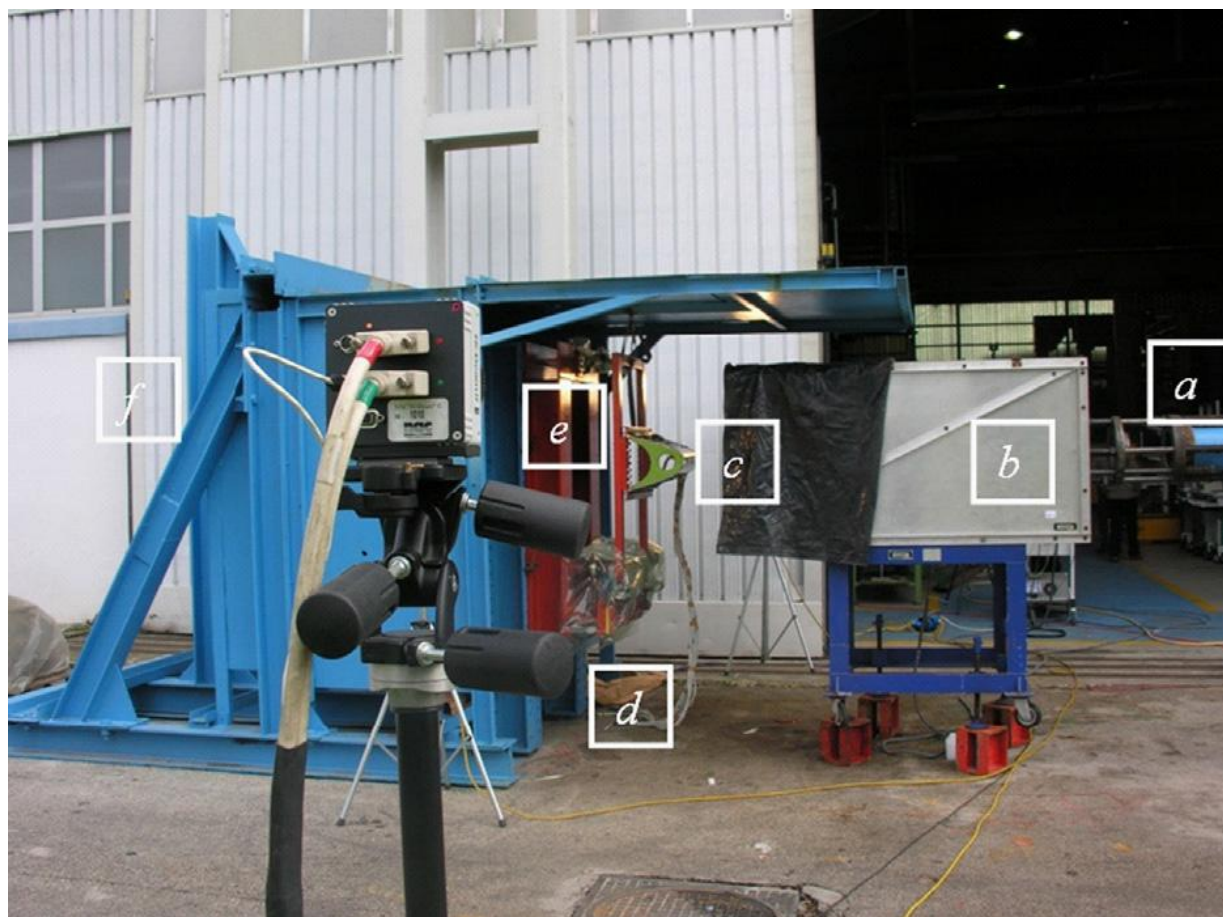
### Bird Impact Test high speed acquisition camera

Fixture and scenario of a bird-strike test.

- a – air cannon bore;
- b – velocity measure device;
- c – test article;
- d – high speed camera;
- e – test bed;
- f - safeguard screen;
- g – load cell.

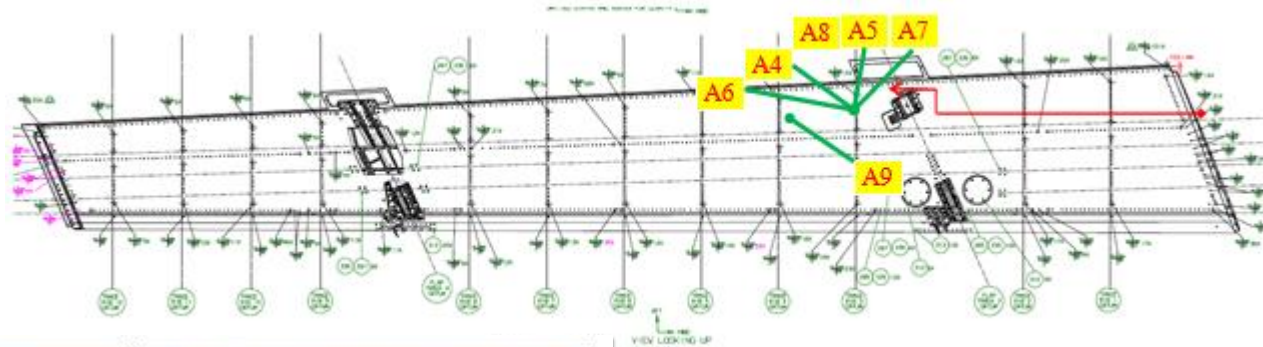
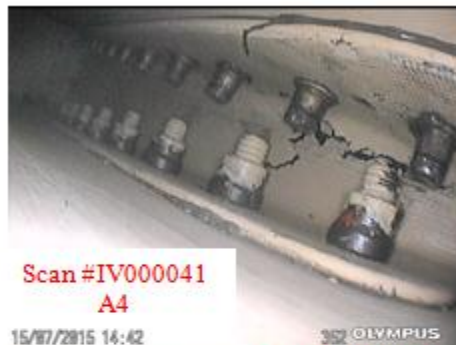
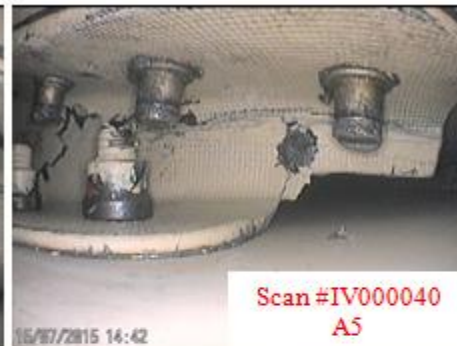
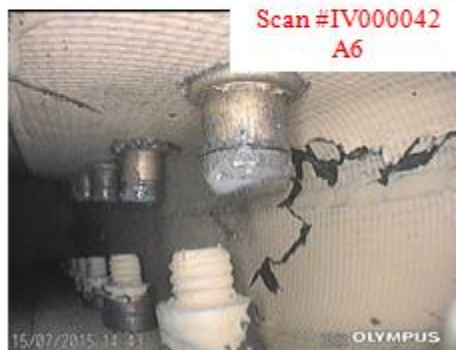
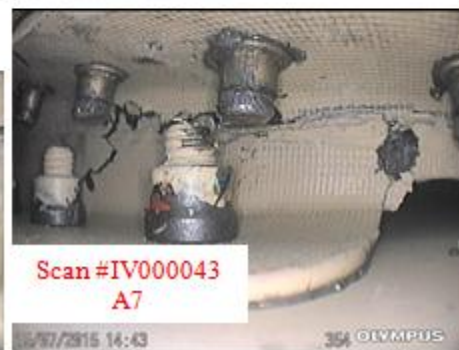
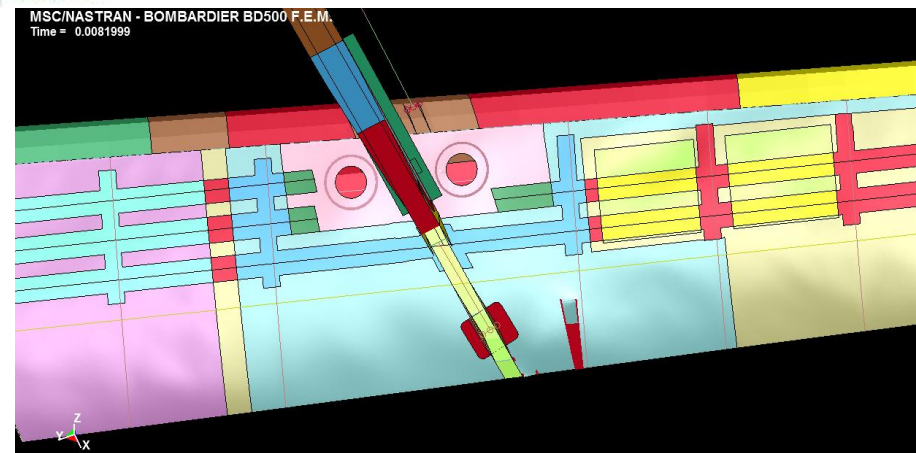
## VISUAL INSPECTION BY USING BORESCOPE PROBE

Failure of composite lower skin+trailing edge rib foot was predicted by model simulation
